**Flood Control Project Maintenance
Levee Inspections**
LMA District Cover Sheet
Spring 2019 Levee Inspection Results

American River Flood Control District

Spring 2019 Levee Inspection Results

Waterway			Bank	Unit Miles
Unit No. 01 Arcade Creek			Left	2.08
	Spring (March - May)	Summer (June - August)	(September - November) Fall	Winter (December - February)
Unit Maintenance Rating (Fall Only)				
Date of Inspection	5/14/2019 - 5/14/2019			
DWR Inspector	Luz Dial			
Accompanied By	Ross Kawamura ARFCD

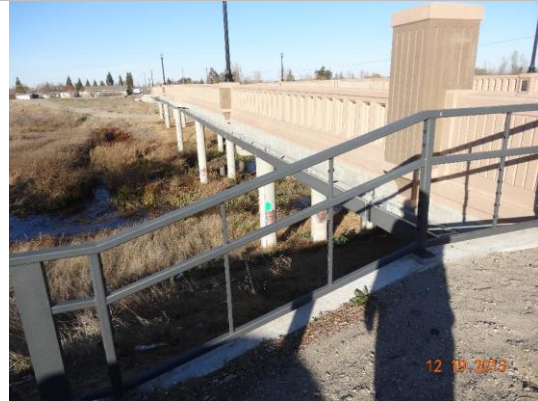
Photo 1 of 3 : UCIP_SP_2019_53488_57042.jpg

FS_ID:53488
DS_ID:24266
EP_NO: 18641-1
Repair Type: Non-Urgent
Crossing Status: Found
UCIP Comments: 07/18/2018 Crossing appears to be the same as last time. Markers have not been placed. PG&E provided supporting documentation that this crossing is in good shape. Plus it is getting raised to the 200-year water surface elevation. PG&E records for this distribution main indicate that there were no leaks found on the 06/2017 leak survey and the pipeline is operating correctly according to the 12/2016 CP inspection. Crossing is downgraded to "Non-Urgent" until the gas line is raised to the 200-year level. (A. McDonald - DWR UCIP)8/11/2016 Markers still missing. LMA representatives, Tim Kerr and Richard Marck, provided permit for 4-inch PG&E gasline to be raised to 200-year water surface elevation. Pipe will be modified on both the right and left bank. Elevation through the levee will need to be modified once pipe is raised through levee. (DWR UCIP - omagana)12/19/2013 no markers visible on waterward or landward side indicating this is a gas line--need to contact owner to determine if this crossing is gas line. (DWR UCIP - omagana)

View of WS--pipe suspended along downstream face of bridge.

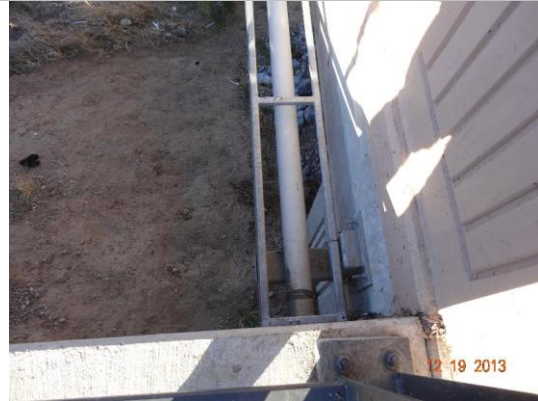
Photo 3 of 3 : UCIP_SP_2019_53488_57040.jpg

View of pipe suspended over waterway.

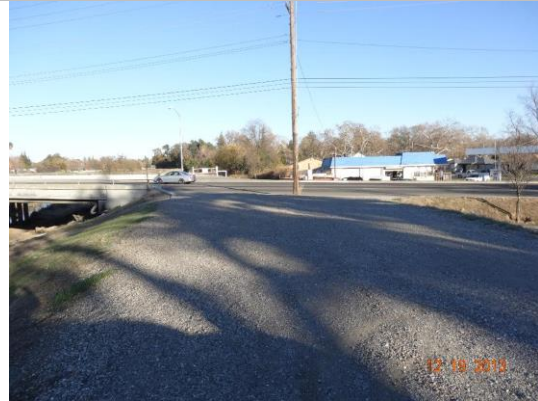
Photo 1 of 3 : UCIP_SP_2019_53490_75855.jpg

Comment Code					
Inspector Comment					
FS_ID:53490 DS_ID:24252 EP_NO: 15152-1 Repair Type: Non-Urgent Crossing Status: Found UCIP Comments: 07/18/2018 Markers missing. This pipeline is abandoned, cut, and capped at the north end of the Rio Linda Blvd bridge. The pipe going through the north levee is open on the WS end. This line is supposed to be raised to the 200-year water surface elevation. PG&E records for this distribution main indicate that there were no leaks found on the 07/2017 leak survey and the pipeline is operating correctly according to the 12/2016 CP inspection. Crossing downgraded to "Non-Urgent" pending documentation that this gas line has been abandoned properly. (A. McDonald - DWR UCIP)8/11/2016 Markers still missing. Unable to confirm if line will be raised to 200-year water surface elevation at this site. (DWR UCIP - omagana)12/19/2013 Need to confirm if this crossing is gas line. Need to contact owner to determine status of crossing (active or inactive) and to determine last inspection date. Will need copy of letter showing crossings passed inspection. Missing utility markers. (DWR UCIP - omagana) FIELD_STRUCT_DESC: *ABANDONED* 4-inch steel gas main through the levee, 2.5 feet below the crown. Vent on the waterside (WS) shoulder. Unable to confirm if crossing will be raised to 200-year water surface elevation within Unit 1. Pipeline was abandoned, cut, and capped at the north end of the Rio Linda Blvd bridge. In case of an emergency related to this pipeline, PG&E has identified the following contacts: PG&E's local pipeline engineer, Mike Aronoff at 916-307-9472 (cell), and Gas Control (north) at 800-442-4743. For non-emergency issues, please contact the local PG&E Gas Pipeline Operations and Maintenance (GPOM) supervisors for the Sacramento region, David Wade at 209-639-1039 (cell), or Ron Hicks at 916-396-9038 (cell). (4-inch gas line installed under Permit No. 15152, 1989 - Pacific Gas & Electric Company [PG&E], 4-inch gas line raised above the 200-year water surface elevation under Permit No. 15152-1, 2016 - PG&E) [Additional Reference(s): DWR Levee Log, 2002] FS Date: 7/18/2018

View of levee crown where crossing should be--no markers found.

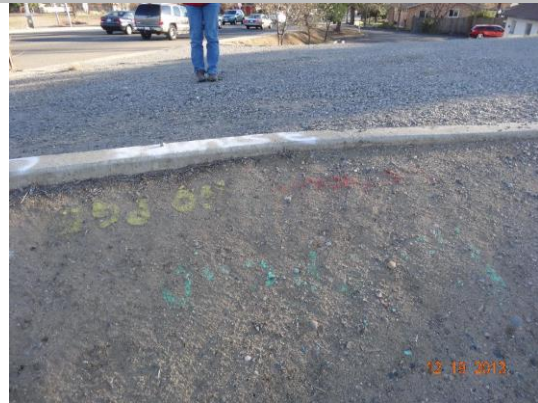
Photo 3 of 3 : UCIP_SP_2019_53490_75857.jpg

Underground service alert (USA) markings found on WS shoulder, photo 2 of 2.

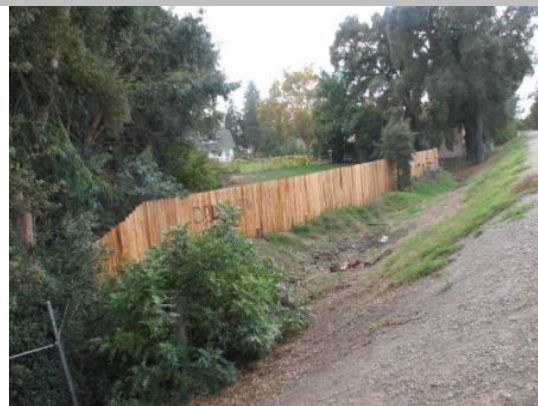
Photo 1 of 1 : SP_2019_NA0001_51_176_20190307_00055.jpg

11/17/2011 Wooden privacy fence built within 15' of the levee toe.

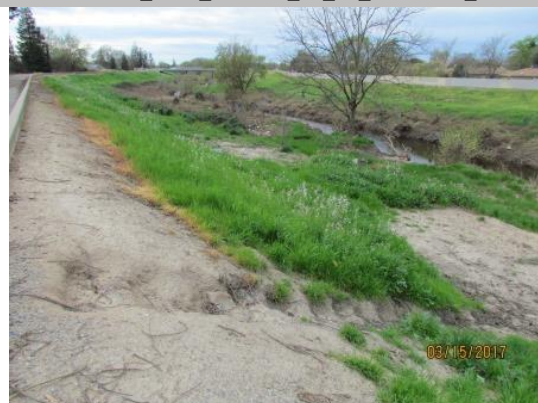
Photo 1 of 1 : SP_2019_NA0001_51_75_20190307_00049.jpg

LM Start	1.48	Rating **	M	Issue No.	75
LM End	1.48	Issue Type +	Ma	Location *	WS
Category	Earthen Levee			GPS Latitude/Longitude	
				Start	End
Item	Slope Stability			38.626912 °	38.626912 °
				-121.443229 °	-121.443229 °
DWR ID	DWR_NA0001_01_s_2017_75				
Comment Code					
S2 : Repair the levee slope damaged by foot traffic and prevent access where possible.					
Inspector Comment					
Stairs dug into waterside levee slope.

View of the stairs in the levee slope, looking downstream.

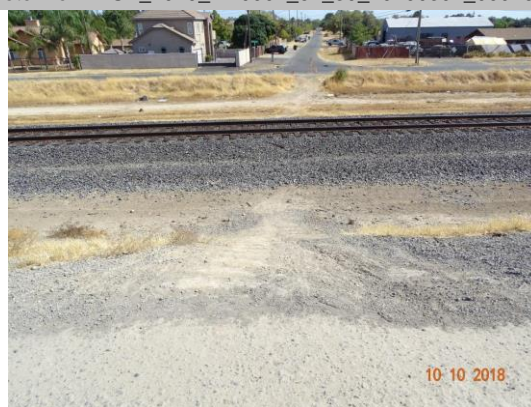
Photo 1 of 1 : SP_2019_NA0001_52_30_20190307_00016.jpg

View of stairs steps dug into levee slope. Fall 2018

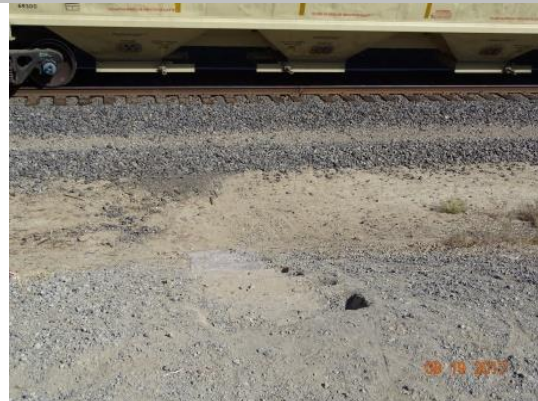
Photo 1 of 1 : SP_2019_NA0001_52_1_20190307_00001.jpg

View of the unpermitted steps in the levee.

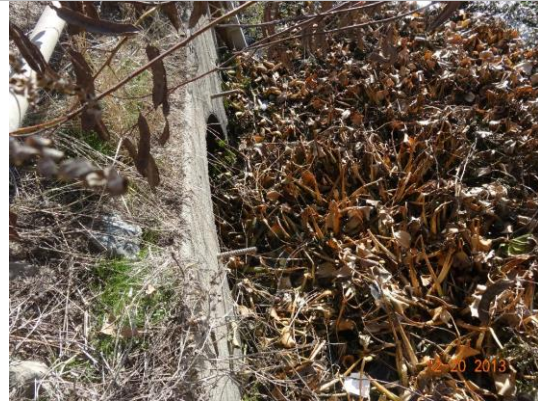
Photo 3 of 3 : UCIP_SP_2019_53492_52913.jpg

Gate missing for 3rd pipe on WS.

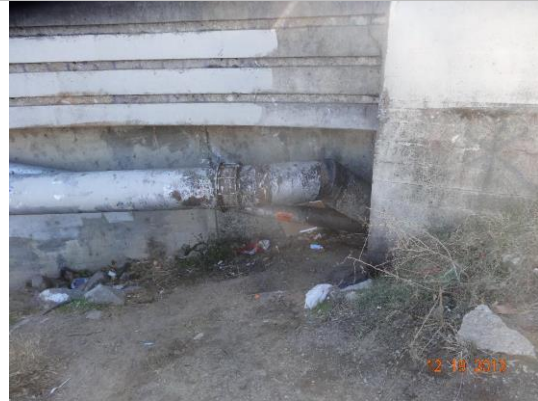
Photo 2 of 3 : UCIP_SP_2019_52685_55421.jpg

Larger line is not marked as gas line and smaller line has label indicating gas line.

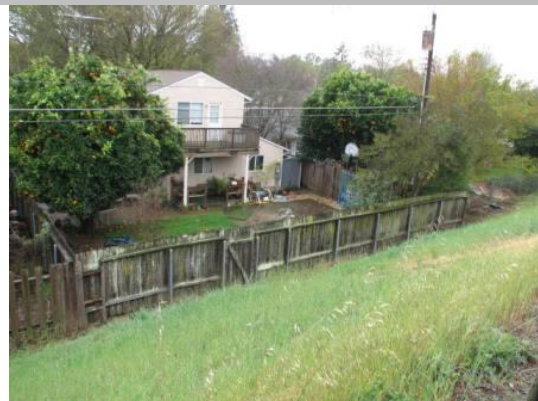
Photo 1 of 1 : SP_2019_NA0001_55_40_20190307_00033.jpg

03/16/2012 Wood privacy fence completely obstructs access and visibility.

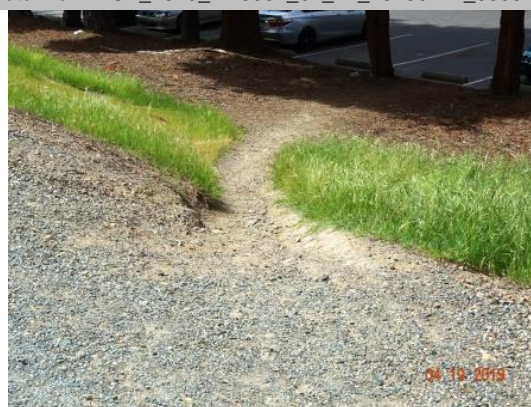
Photo 1 of 2 : SP_2019_NA0001_61_21_20190422_00052.jpg

View of footpath on landside slope. Spring 2019

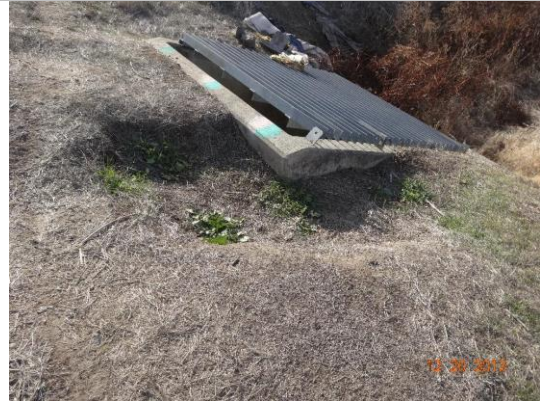
Photo 3 of 3 : UCIP_SP_2019_31313_57351.jpg

Concrete headwall located on waterward side--depression found on wall edge.

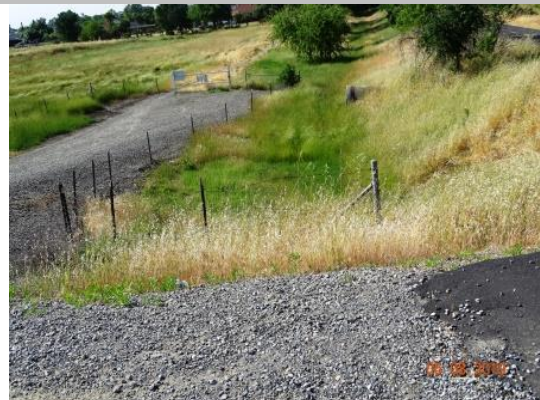
Photo 1 of 1 : SP_2019_NA0001_436_5_20190513_00009.jpg

View looking southward at barbed wire fence at levee toe. Spring 2019
